Forensic Building Science, Inc.
657 Lincoln Avenue St., Paul Minnesota 55015

Client: Hollingsworth Investments VI Project Address: 88 Armory Road Vicksburg, Mississippi 39183 Warren County	Insurance Carrier: Cincinnati Insurance Company Policy #: Unknown Claim #: 2831900 Date of Loss: August 8, 2015 Claim Type: Hail, Wind, Water
---	--

FIELD REPORT FOR INITIAL STORM DAMAGE INVESTIGATION

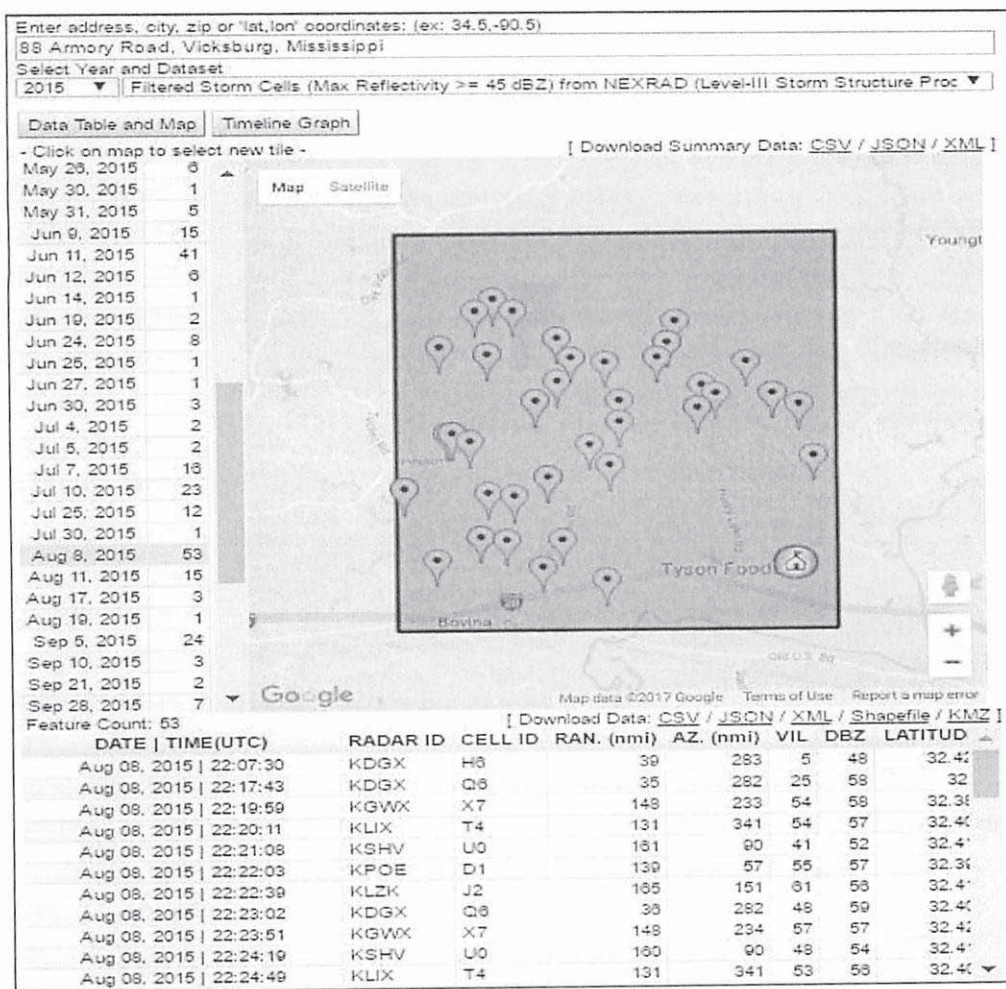
NOAA Severe Weather Inventory Filtered Storm Cells August 8, 2015:

According to the National Oceanic and Atmospheric Administration's (NOAA) storm event database, a total of 53 storm related events and 48 hail related events are recorded for August 8, 2015 near the facility. This is the largest concentration of storm activity in all of 2015 and 2016 for this location. Hail was recorded at 1.75 inches less than 3 mile from the site with the storm moving toward the site.

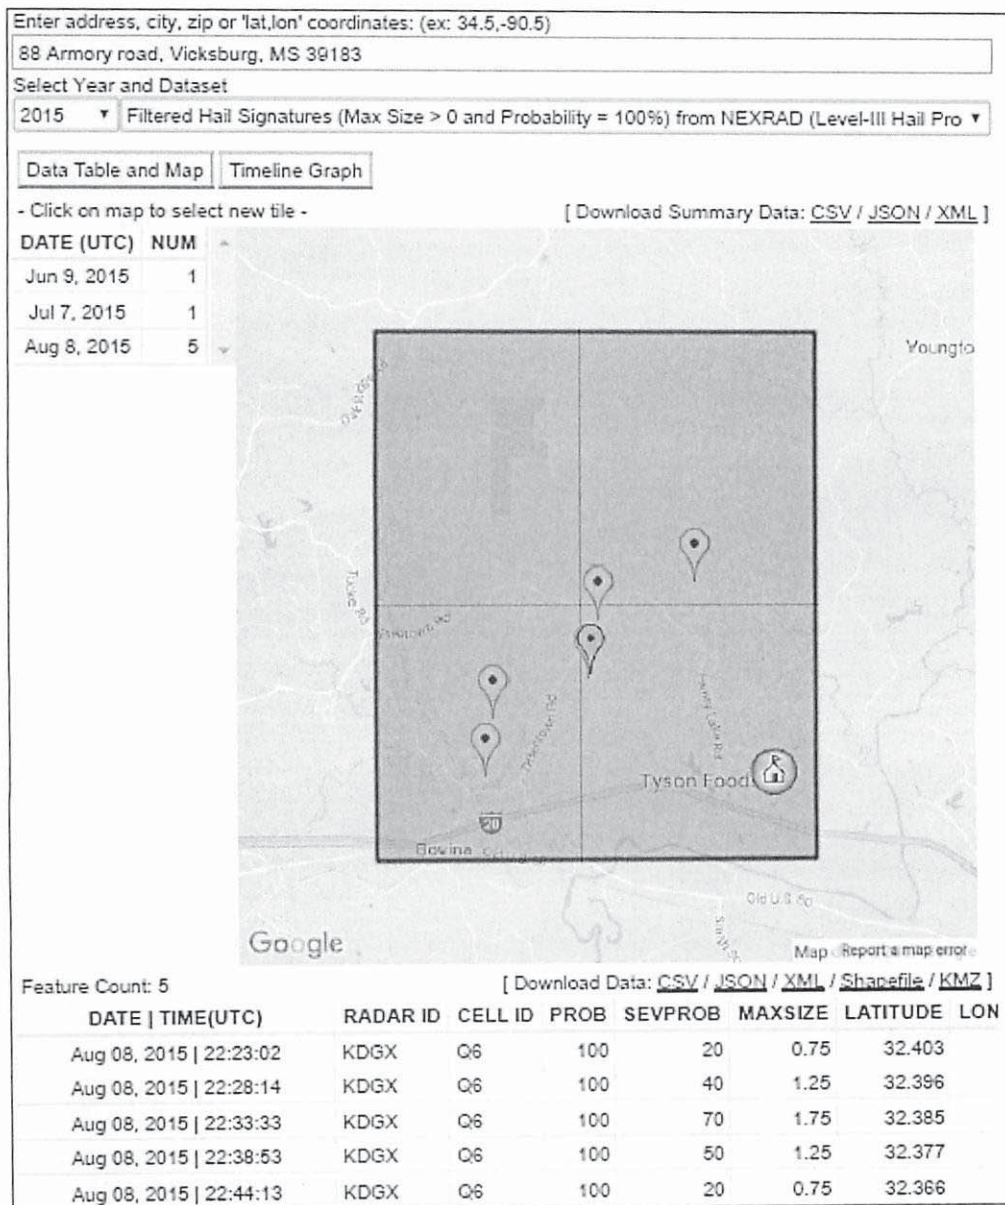
NOAA Severe Weather Inventory Filtered Hail Signatures August 8, 2015:

1.75 Inch hail at green balloon

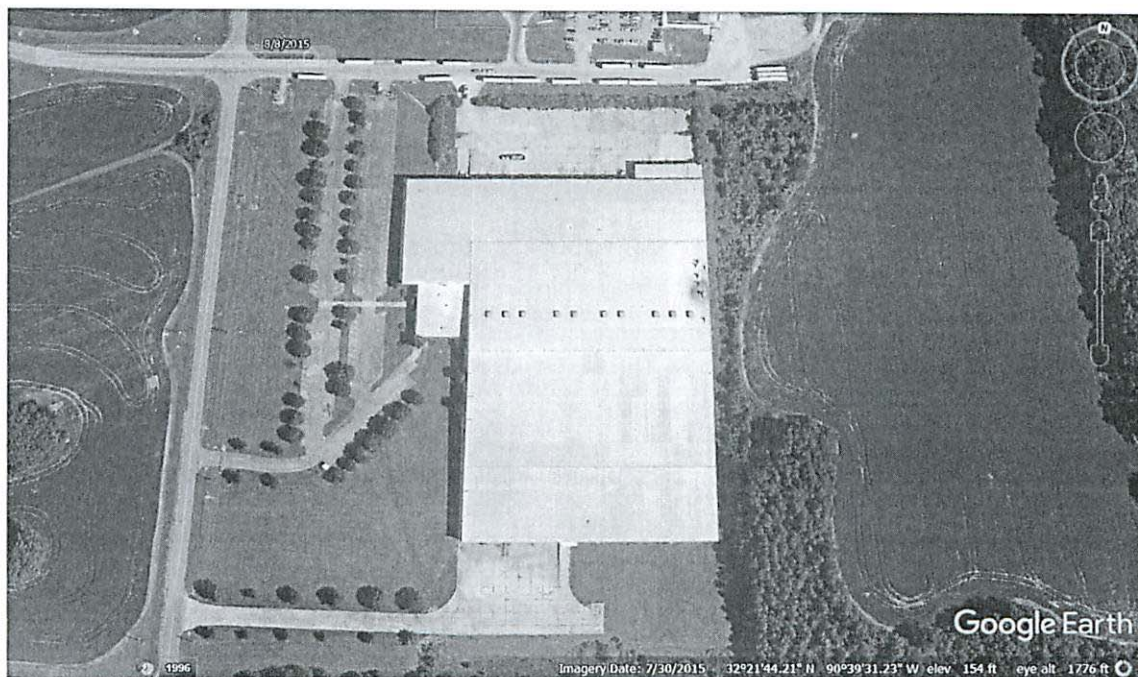
1.3 Satellite Image of the Property:

Google Earth imagery before the storm event(s) dated July 30, 2015.

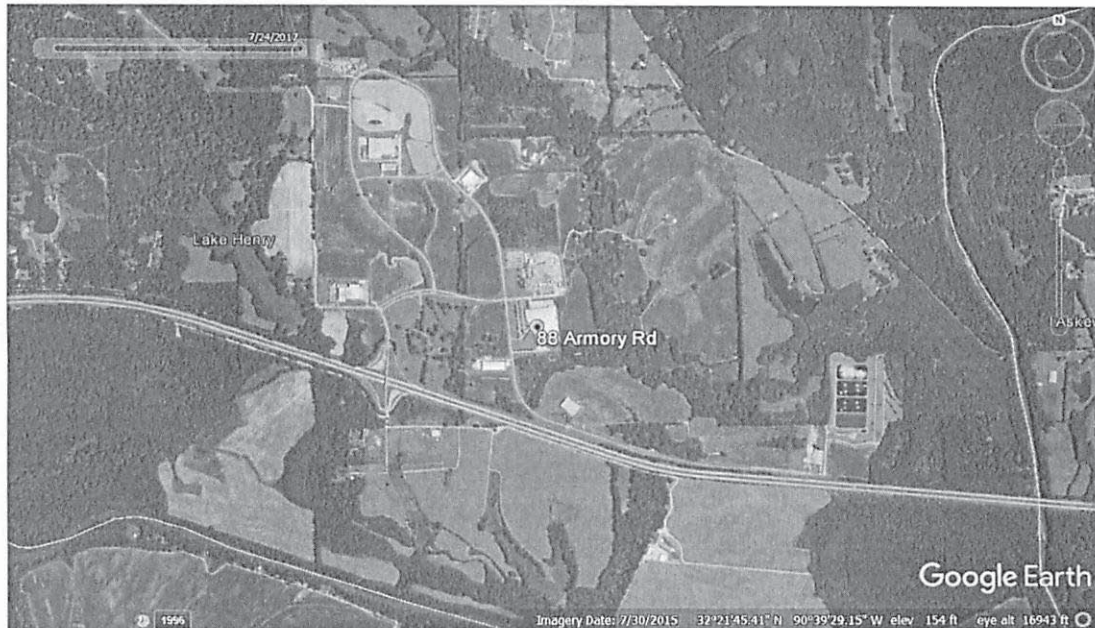
Google Earth imagery of terrain surrounding property dated July 30, 2015.

- Area is surrounded by properties consistent with the definition of Exposure C in ASCE 7.
